Home Inspection Report

261 Church St S
Richmond Hill, Ontario L4C 1W8

Inspected by:
Robert Rainerri
Inspec Homes

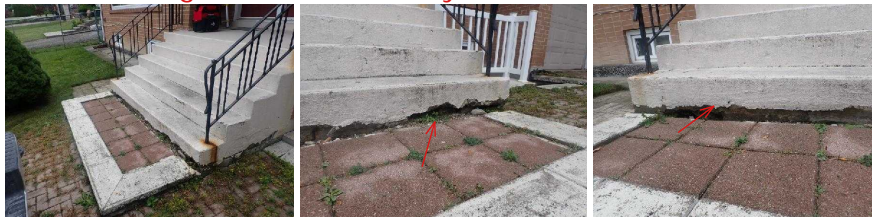
Acceptable, Marginal Steps/Stoops: Concrete, Paver, Wood - -- **Deterioration on bottom concrete step present with erosion of material. Recommend repairs to reduce cracking and breaking issues over the years.**

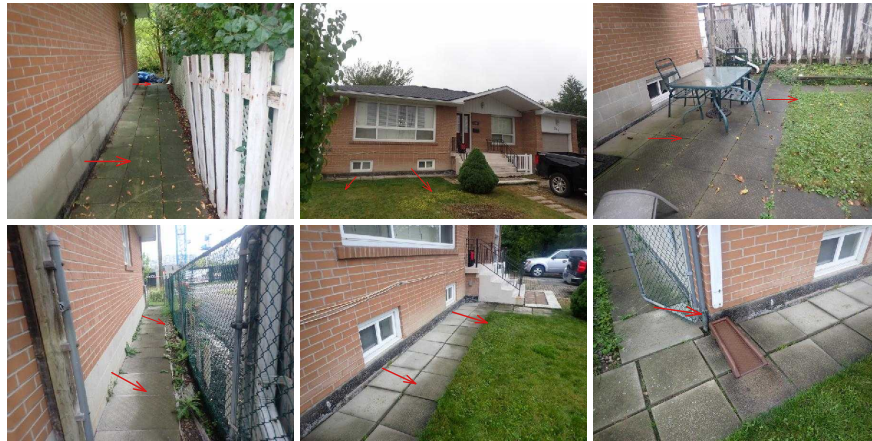
Grading: (continued)

Acceptable, Marginal Grading: Moderate slope, Negative slope - -- Grading is negative in areas around property, grading is very important, recommend always ensuring a proper slop away from homes foundation, to reduce water penetration in to the interior in the future.

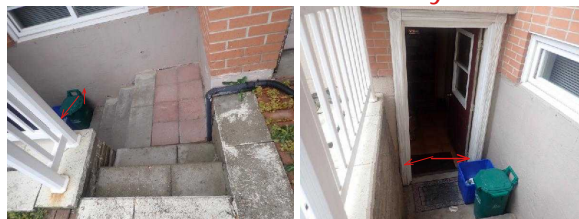
Acceptable, Marginal Basement Stairwell: Stone - -- Railings missing recommend installing railings to reduce fall hazard over the years.

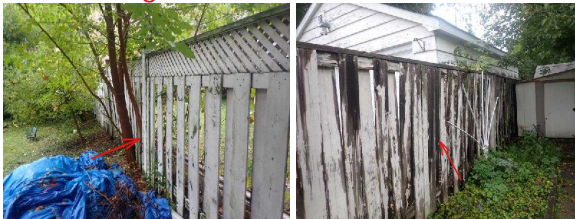
Fences: Wood - -- Old wood fencing with leaning posts and damaged areas, upgrading the damaged areas is recommended.

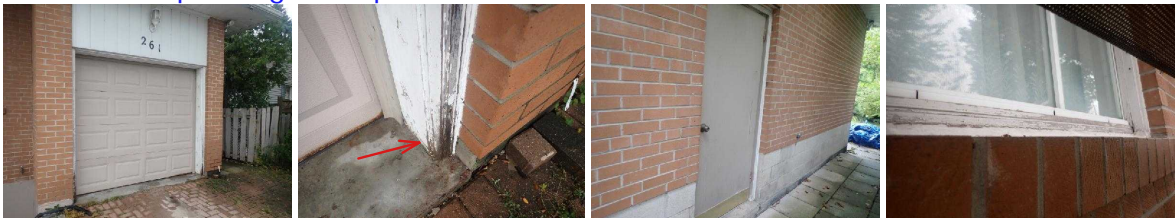
Trim: Wood - -- Always recommend sanding and painting trim around doors and windows to prolong life span.

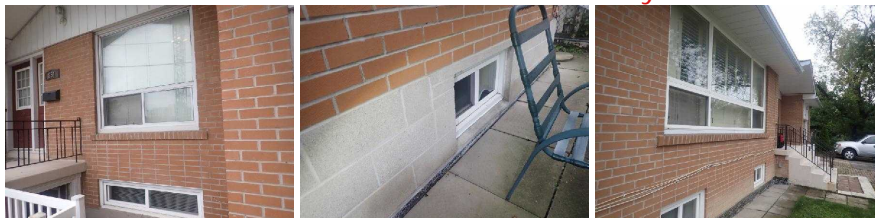
Acceptable, Marginal Windows: Vinyl - -- Caulking around the windows is a must to avoid any water penetration and should be done and review yearly to ensure no gaps are present. Windows are getting older upgrading when you have the money is recommended for better R value over the years.

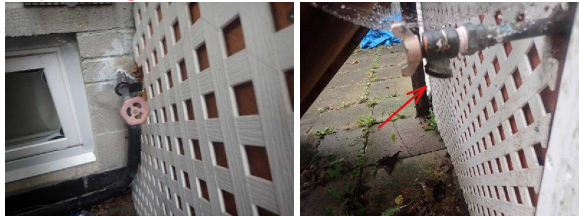
Acceptable, Marginal Hose Bibs: Rotary - -- Always recommend to shut off exterior hoses in garage and yard from the interior and bleeding the lines to reduce freezing damage in the winter months. Hose bib at back of home is leaking recommend replacing shut off.

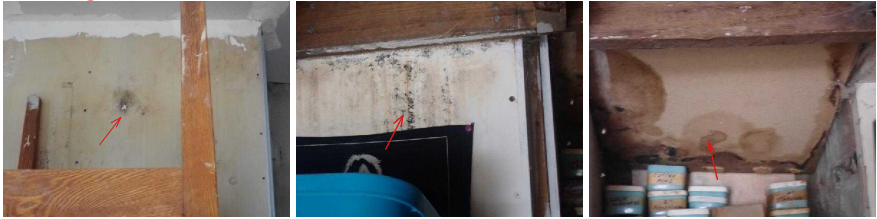
Marginal Ceiling: Drywall - -- Past water damage with mold present on walls and ceiling from roof leak in the past. Recommend replacing all damaged drywall to reduce further mold growth.

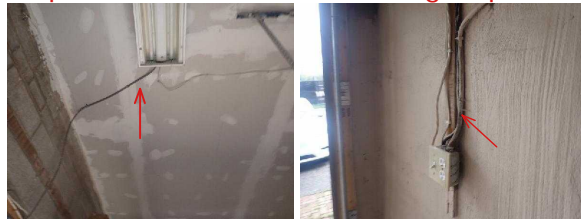
Acceptable, Marginal Electrical: 110 VAC - -- Some lighting and wiring not operating at time inspection recommend having a qualified electrician inspect and evaluate.

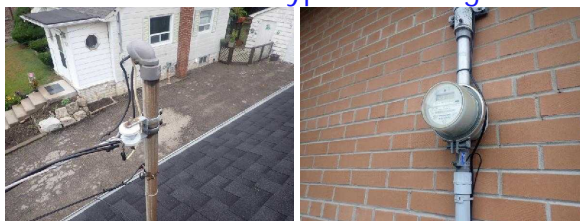
Acceptable, Not Inspected Service: Access Blocked - -- No access to main feed noted, was unable to determine the type of wiring.

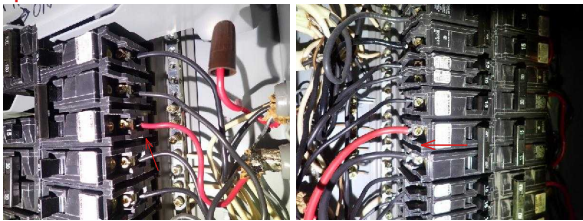
Acceptable, Marginal Aluminum Wiring: Present - -- Aluminum wiring is present, recommend inquiring with your insurance company to ensure an ESA is not required, if it is a qualified electrician is needed to evaluate and estimate repairs if needed.

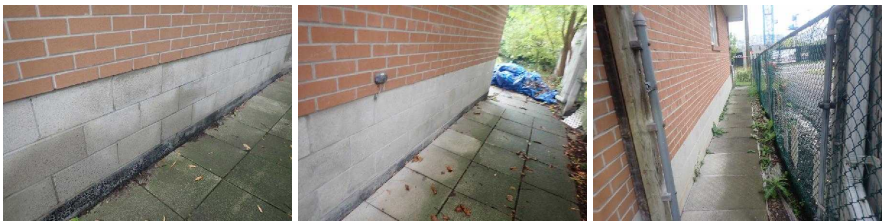
Acceptable Foundation: Block - -- Recommend parging every few years to protect the foundation wall from the exterior elements.

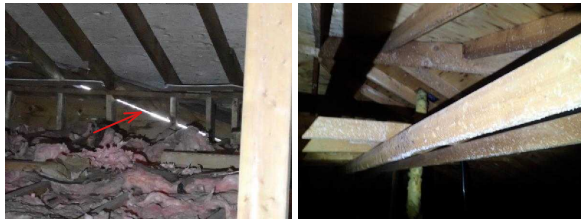
Roof Framing: (continued)

Acceptable, Marginal Roof Framing: 2x4 Rafter - -- **Open gap at front of home that is allowing light into attic and therefore will most likely allow animals and moisture as well. Recommend sealing this area to reduce future issues.**

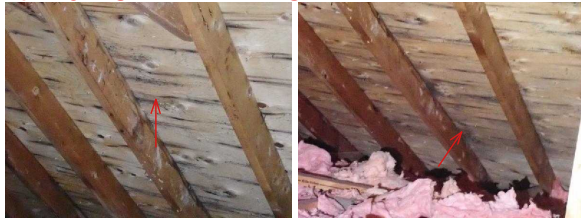
Acceptable, Marginal Sheathing: Plywood - -- Small amount of mold noted in some areas recommend spraying and sealing with a mold killer to reduce spreading in the future.

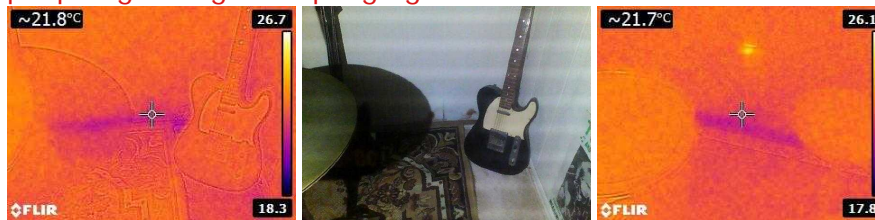
Moisture Location: Some low areas - -- Active water intrusion noted on West Wall bedroom area and East wall laundry room area. Water intrusion was noted at time of inspection recommend a further investigation by a qualified waterproof company. Cinder block can be very pores and tends to allow moisture in over the years if negative grading is present, recommend ensuring proper grading with parging on block to reduce this issue.

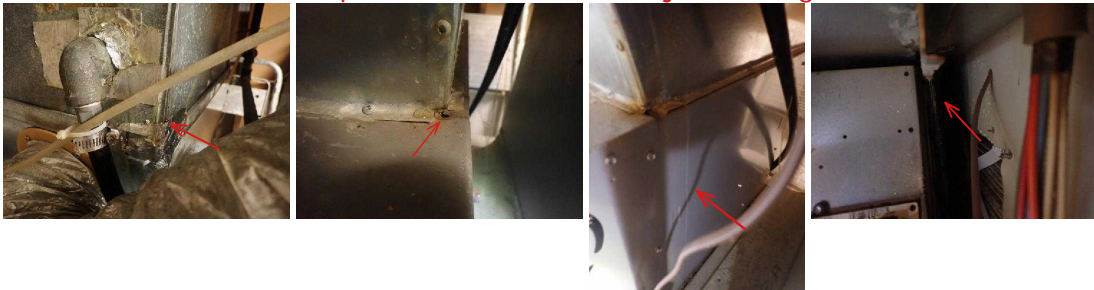
Condensate Removal: Plastic tubing - -- Leaking line in to the interior of unit, repairs are needed as soon as possible to reduce major damage to unit.

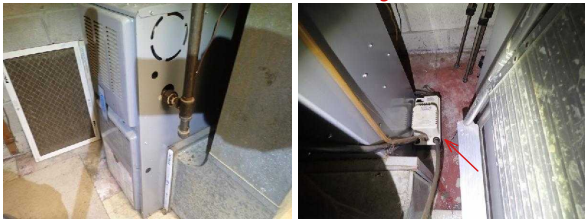
Acceptable, Marginal Heating System Operation: Functional at time of inspection - -- Recommend servicing once a year to keep up with maintenance and help pro long life. Condensation pump is not operating repairs are needed to avoid leaking in and around the unit over the years.

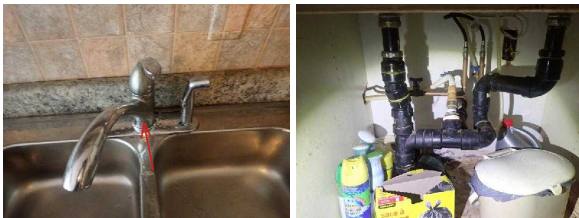
Plumbing/Fixtures: ABS - -- Faucet head is leaking a time of inspection replacing a faucet head is needed.

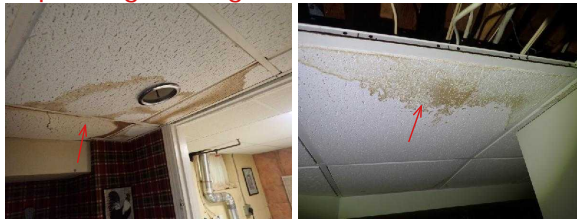
Acceptable, Marginal Ceiling: Paint, Suspended ceiling - -- Old past water staining recommend replacing damaged tiles.

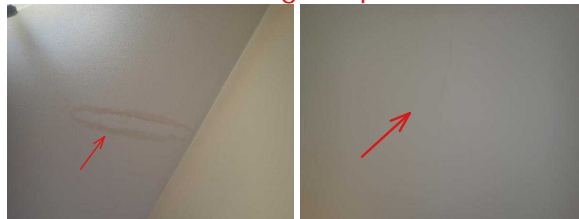
Acceptable, Marginal Ceiling: Paint - -- Past water leaking from old roof recommend repairs. No active water damage is present a time of inspection.

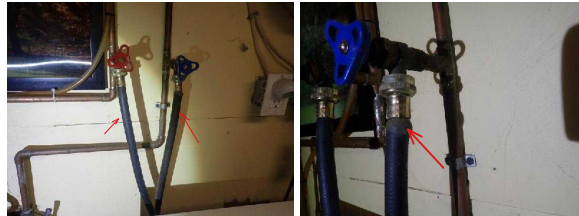
Acceptable, Marginal Washer Hose Bib: Rubber Hoses - -- Rotary with rubber hoses--- Rubber hoses can rupture over the time causing flood, as this laundry facility is on a second floor and or in finish basement recommend upgrade to braided lines

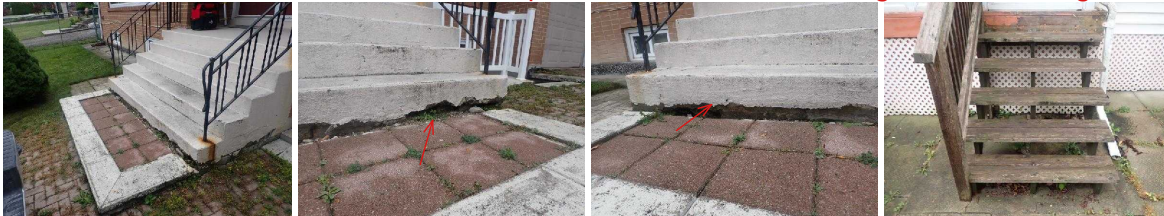
1. Steps/Stoops: Concrete, Paver, Wood - -- Deterioration on bottom concrete step present with erosion of material. Recommend repairs to reduce cracking and breaking issues over the years.

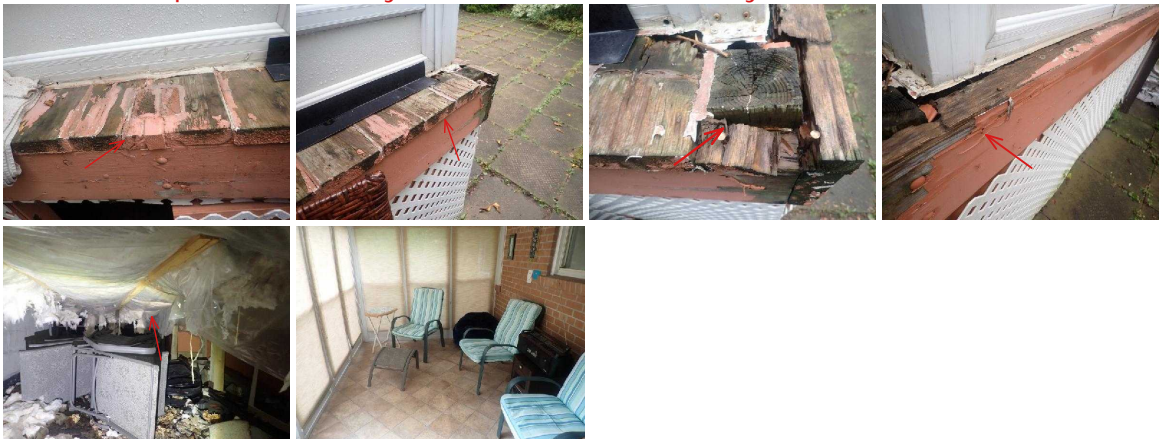
2. Deck: Wood, Enclosed - -- Deck wood is in poor shape with rotted areas. Recommend upgrading deck to help with stability of structure over the years.

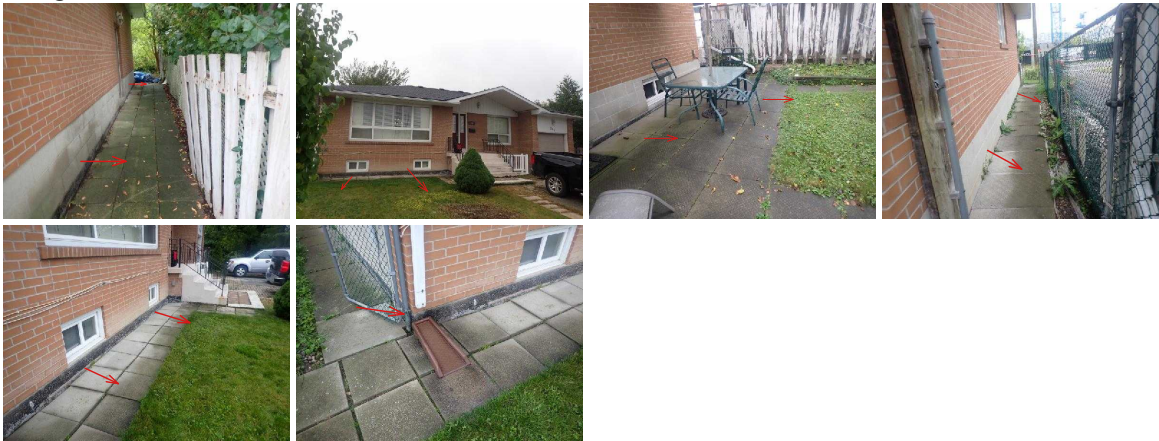
Grading: (continued)

3. Grading: Moderate slope, Negative slope - -- Grading is negative in areas around property, grading is very important, recommend always ensuring a proper slop away from homes foundation, to reduce water penetration in to the interior in the future.

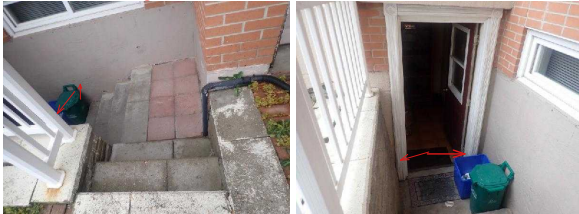
5. Basement Stairwell: Stone - -- Railings missing recommend installing railings to reduce fall hazard over the years.

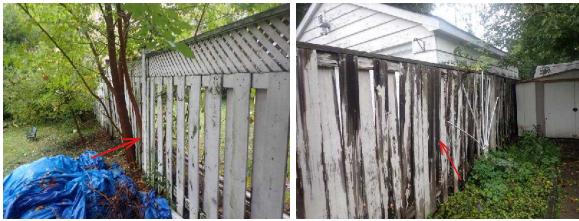
Fences: (continued)

6. Fences: Wood - -- Old wood fencing with leaning posts and damaged areas, upgrading the damaged areas is recommended.

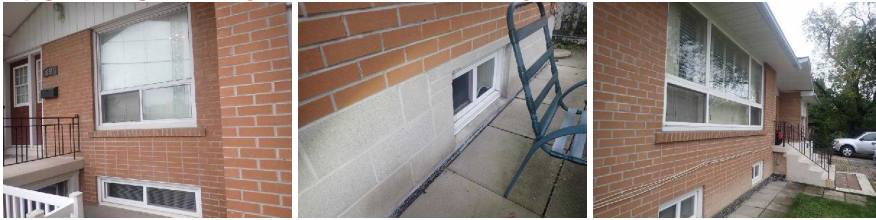
7. Windows: Vinyl - -- Caulking around the windows is a must to avoid any water penetration and should be done and review yearly to ensure no gaps are present. Windows are getting older upgrading when you have the money is recommended for better R value over the years.

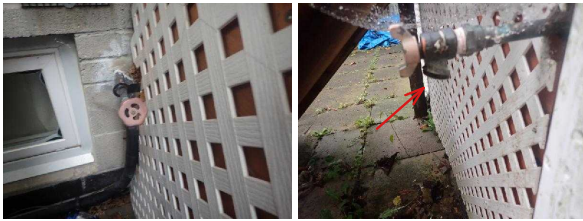
Hose Bibs: (continued)

9. Hose Bibs: Rotary - -- Always recommend to shut off exterior hoses in garage and yard from the interior and bleeding the lines to reduce freezing damage in the winter months. Hose bib at back of home is leaking recommend replacing shut off.

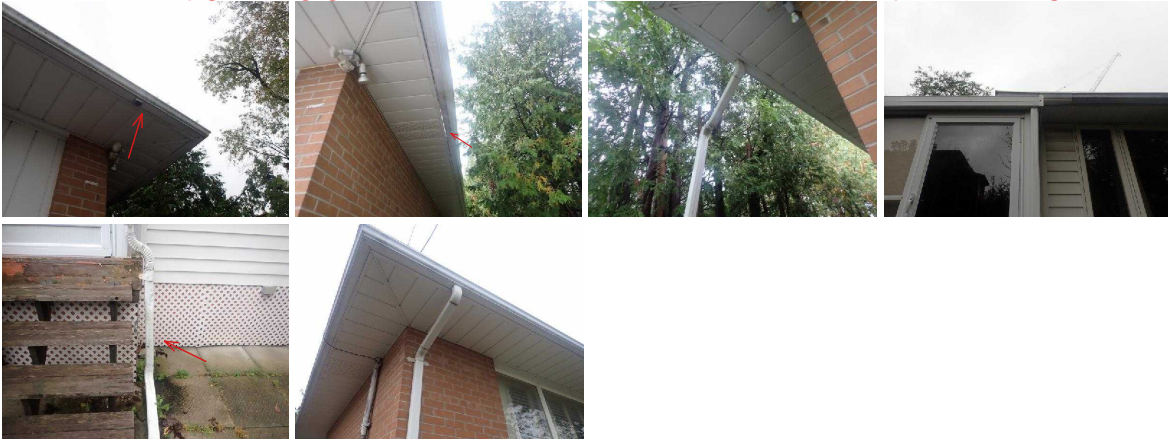
10. Gutters/Downspouts Aluminum - -- Missing and damaged areas around the property noted recommend upgrading gutters and downspouts to ensure proper drainage at all times.

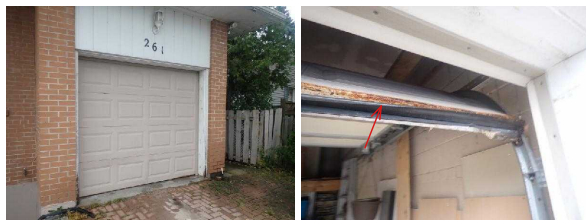
12. Attached Garage Garage Doors: Metal - -- Rusting at bottom of door noted upgrading of door will be needed in the future.

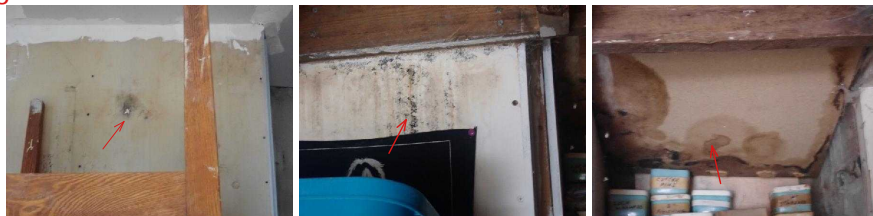
13. Attached Garage Ceiling: Drywall - -- Past water damage with mold present on walls and ceiling from roof leak in the past. Recommend replacing all damaged drywall to reduce further mold growth.

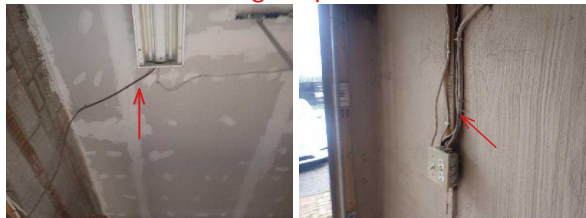
14. Attached Garage Electrical: 110 VAC - -- Some lighting and wiring not operating at time inspection recommend having a qualified electrician inspect and evaluate.

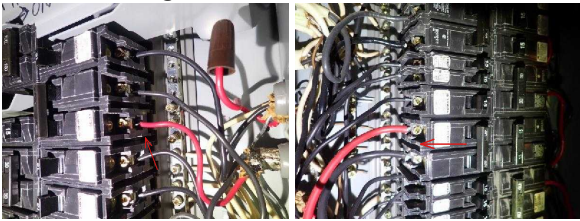
Aluminum Wiring: (continued)

15. Aluminum Wiring: Present - -- Aluminum wiring is present, recommend inquiring with your insurance company to ensure an ESA is not required, if it is a qualified electrician is needed to evaluate and estimate repairs if needed.

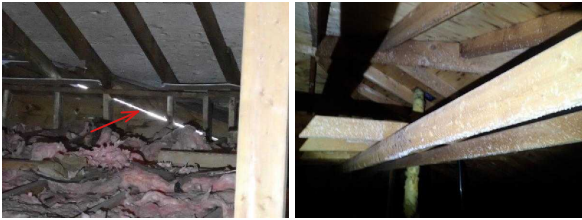
16. Closet Attic Roof Framing: 2x4 Rafter - -- Open gap at front of home that is allowing light into attic and therefore will most likely allow animals and moisture as well. Recommend sealing this area to reduce future issues.

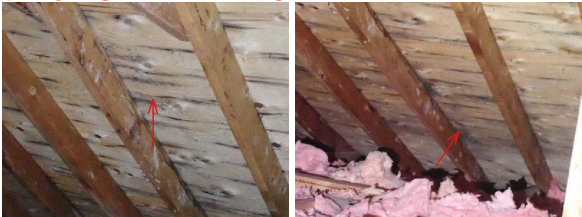
17. Closet Attic Sheathing: Plywood - -- Small amount of mold noted in some areas recommend spraying and sealing with a mold killer to reduce spreading in the future.

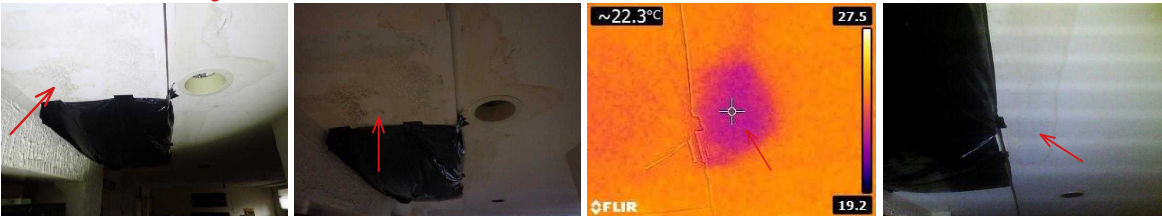
21. Main Basement Ceiling: Paint, Suspended ceiling - -- Active water damage and mold present below upstairs two piece bathroom, a qualified plumber is needed to evaluate and repair. Also removal of affected drywall should be done to reduce health concerns.

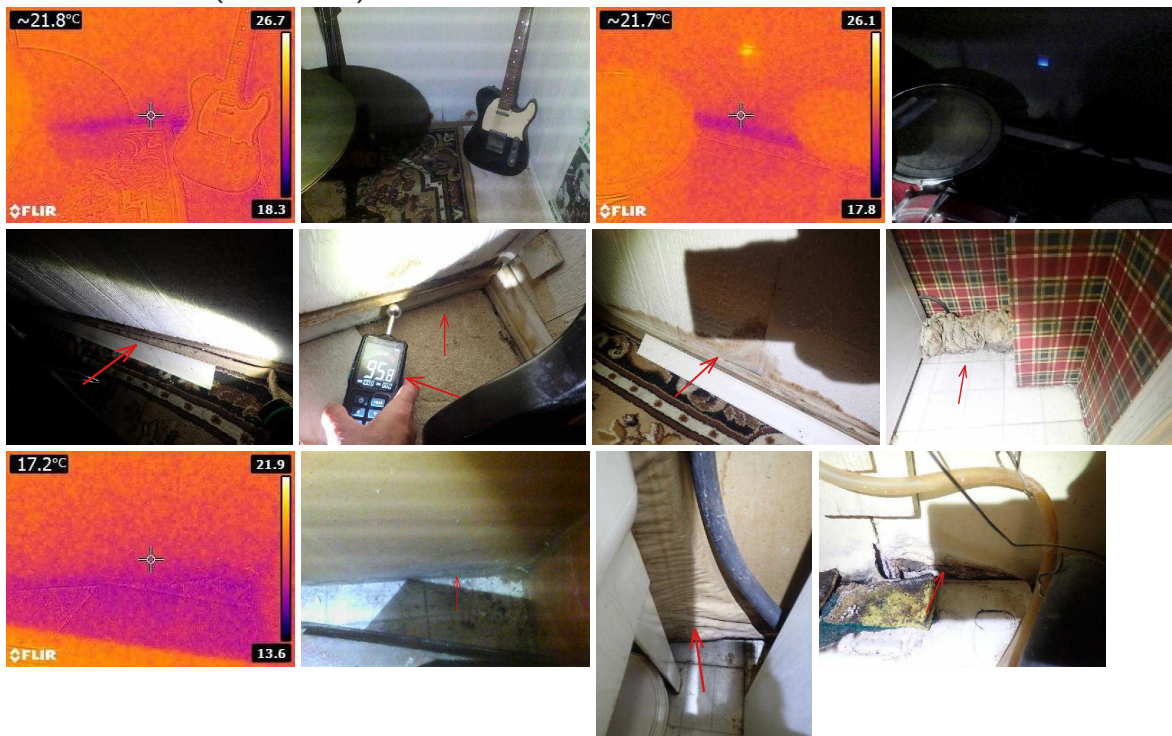
Moisture Location: (continued)

22. Main Basement Moisture Location: Some low areas - -- Active water intrusion noted on West Wall bedroom area and East wall laundry room area. Water intrusion was noted at time of inspection recommend a further investigation by a qualified waterproof company. Cinder block can be very porous and tends to allow moisture in over the years if negative grading is present, recommend ensuring proper grading with parging on block to reduce this issue.

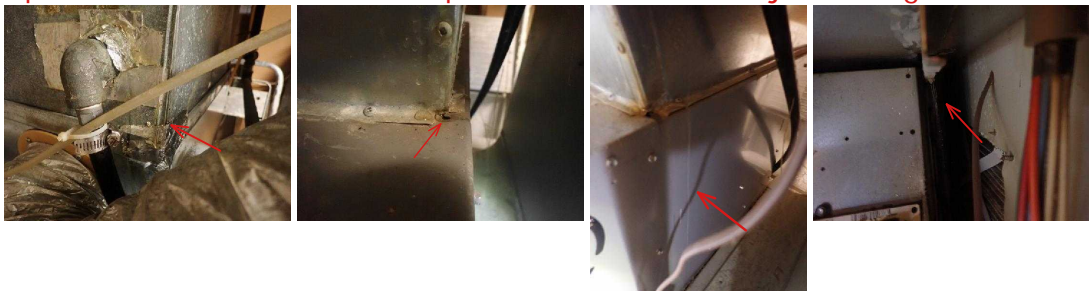
23. Main AC System Condensate Removal: Plastic tubing - -- Leaking line in to the interior of unit, repairs are needed as soon as possible to reduce major damage to unit.

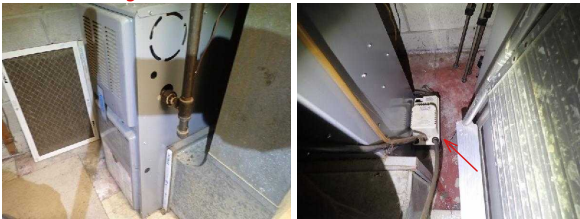
24. Main Heating System Heating System Operation: Functional at time of inspection - -- **Recommend servicing once a year to keep up with maintenance and help pro long life.** Condensation pump is not operating repairs are needed to avoid leaking in and around the unit over the years.

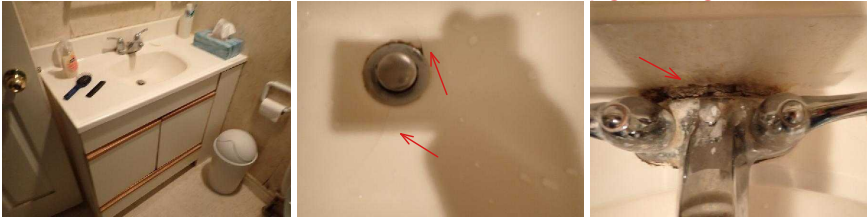
35. Basement Bathroom Sink/Basin: One piece sink/counter top - -- Old sink with hairline cracks and rotted out faucet present recommend upgrading to reduce leaking in the future.

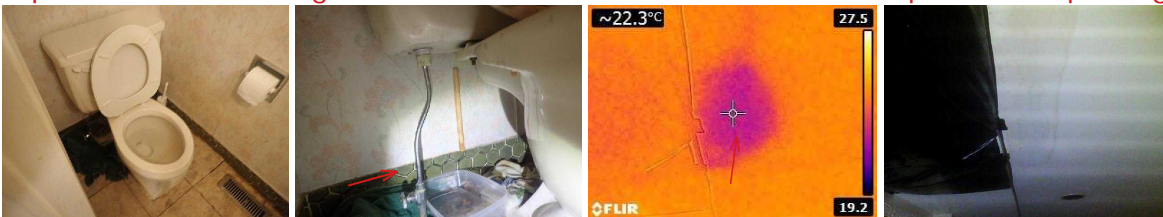
38. 1st floor main Half Bathroom Toilets: American Standard - -- Toilet was not operating a time inspection with leaking noted at the water line recommend repairs or replacing.

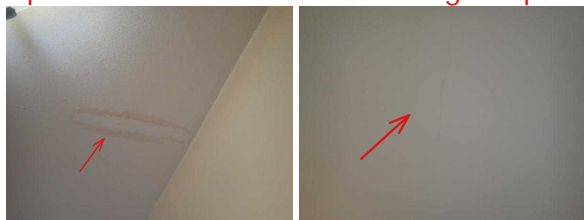
39. Living area main floor Living Space Ceiling: Paint - -- Past water leaking from old roof recommend repairs. No active water damage is present at time of inspection.

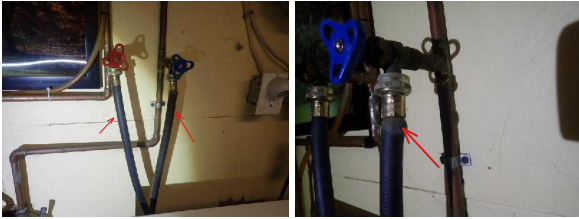
Washer Hose Bib: (continued)

42. Basement Laundry Room/Area Washer Hose Bib: Rubber Hoses - -- Rotary with rubber hoses--- Rubber hoses can rupture over the time causing flood, as this laundry facility is on a second floor and or in finish basement recommend upgrade to braided lines
